# DEBRIS-FLOW HAZARDS IN AREAS AFFECTED BY THE JUNE 27, 1995

## STORM IN MADISON COUNTY, VIRGINIA

OPEN FILE REPORT 97-438

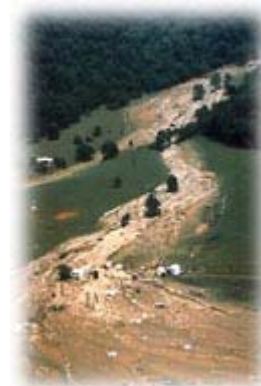
Times of impact 11:30-11:45 to 1:00  
EDT  
(Home of R. Lillard)

Multiple pulses of debris flows were observed in several channels and fans. Near Graves Mill a house was hit and moved by separate debris flows about 1.5 hours apart (Mr. Randall Lillard, oral commun., 8/28/95). An observer east of Graves Mill observed five surges of debris flows moving down a single channel with an estimated velocity of 20 miles per hour about fifteen minutes apart (Mr. Leighton Brown, oral commun., 10/10/95). The unknown amount of time between multiple pulses of debris flows in a channel poses hazards for escape and rescue.
