SITE INVESTIGATION REPORT SOIL EVALUATION SERVICES

Former Firing Range
Soil Investigation
2650 Leroy Road
Virginia Beach, VA
GER 120-6539

Subject: **Soil Investigation Report**
Former Firing Range
2650 Leroy Road
Virginia Beach, Virginia
GER Project #120-6539

Sample Location Plan

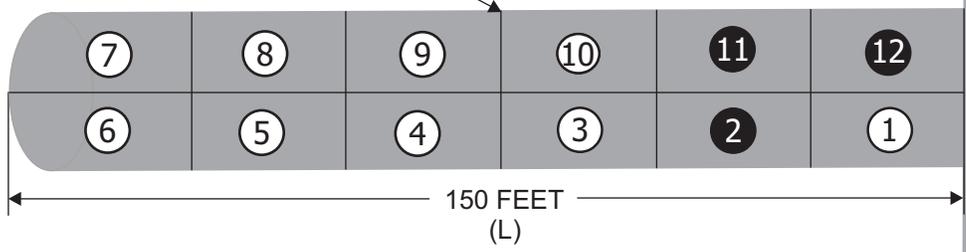
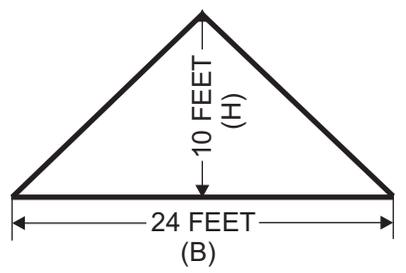
DRAWING 1 OF 1

BACKSTOP BERM
 SIDE WALL BERM
 CENTER SIDE WALL BERM

RANGE #1

RANGE #2

CROSS SECTION

$$V = \frac{1}{2} BH * L$$

$$V = \frac{1}{2} (24 * 10) * 150$$

$$V = 18,000 \text{ cubic feet}$$

$$V = 667 \text{ cubic yards}$$

- # SOIL SAMPLE LOCATION CONTAINING <1% LEAD
- # SOIL SAMPLE LOCATION CONTAINING 0% LEAD

GER inspector Brian Parker made site visits to the former firing range on September 4th, 5th, 6th, and 10th, 2014. Measurements were taken of the center side wall berm in preparation for establishing 12 sample areas within the subject property. Measurements were also taken to better evaluate the number and types of soil characterization samples that may be required in the future to properly manage any contaminated materials found. Please refer to Drawing 1 of 1 for measurements taken and sample locations.

Tables I below, lists the sample locations and results. The laboratory report and drawing showing sample locations are attached.

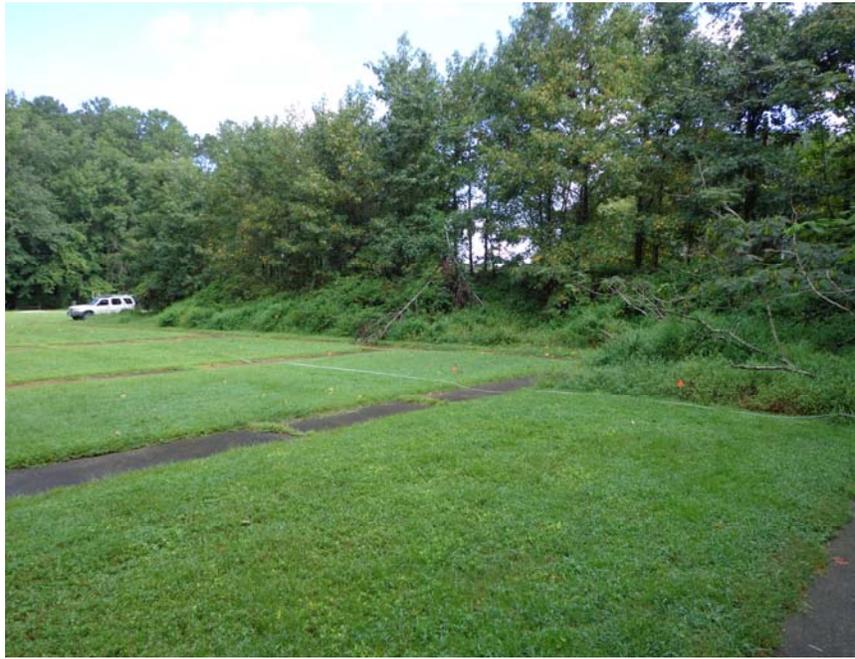
Photo 1: North facing view of the subject property with measuring tape and orange pin flags visible, detailing the 150' length of the center side wall berm.

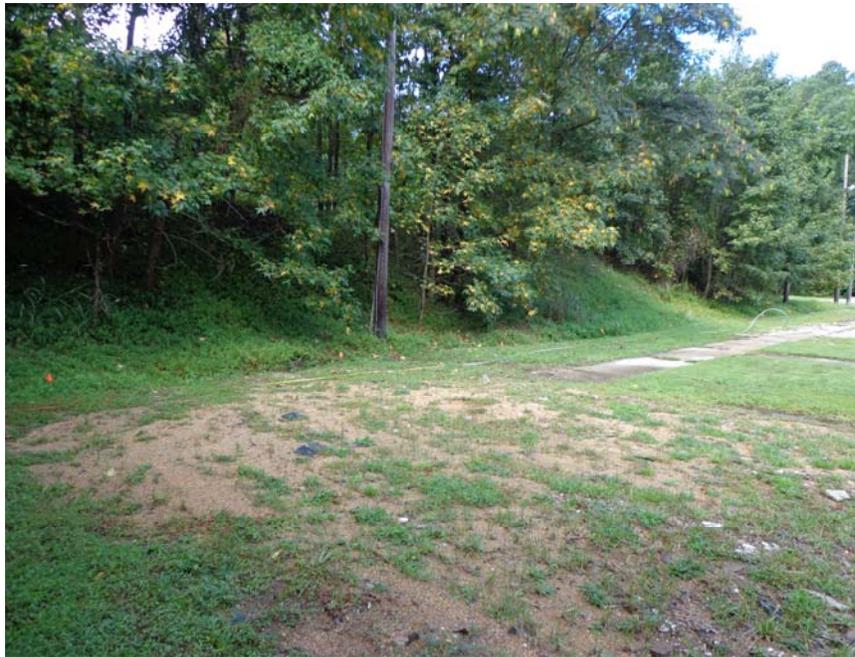
Photo 2: Southwest facing view of the subject property with measuring tape and orange pin flags visible, detailing the 150' length of the center side wall berm.

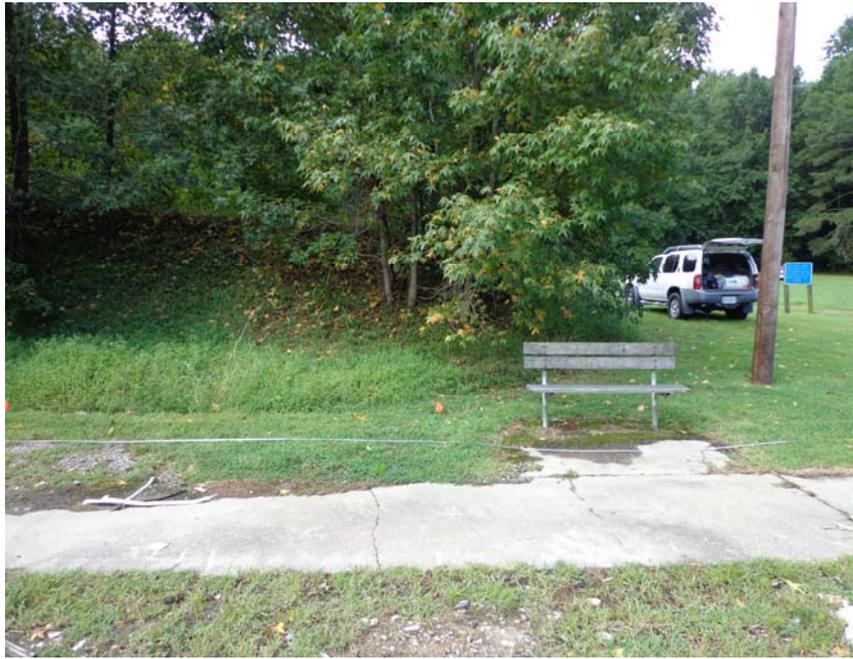
Photo 3: Southeast facing view of the subject property with measuring tape and orange pin flags visible, detailing the 24' width of the center side wall berm.

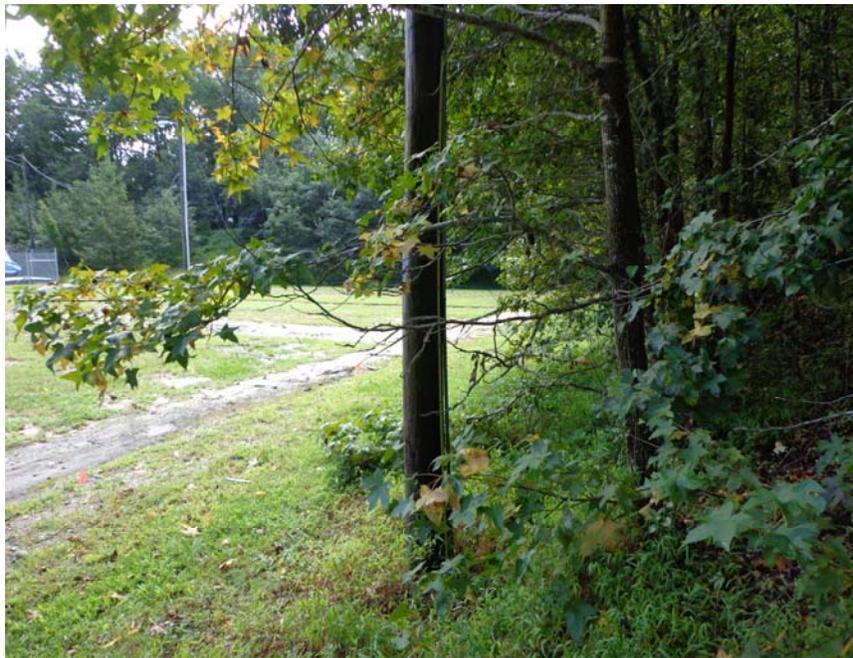
Photo 4: East facing view of the subject property with measuring tape on telephone pole visible, detailing the 10' height of the center side wall berm.

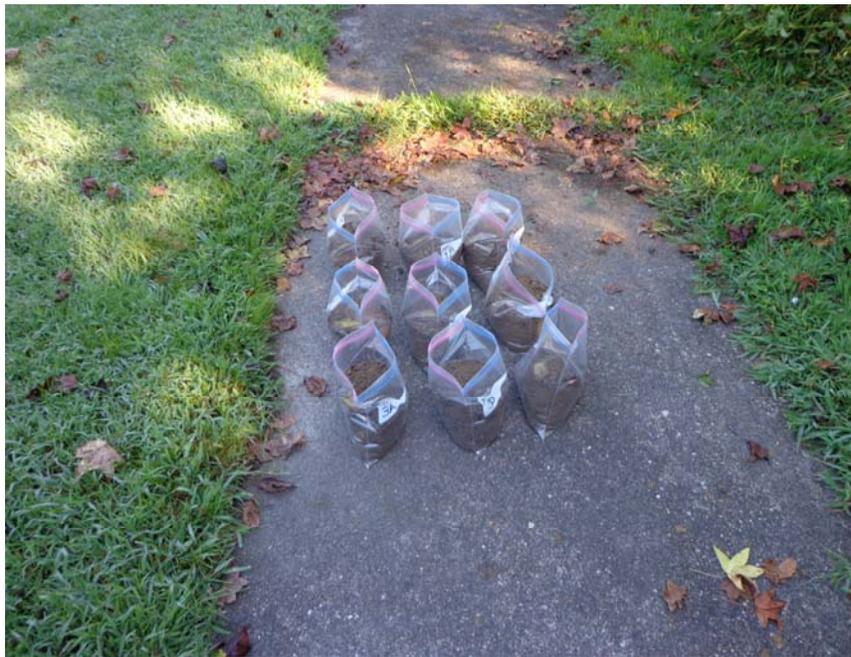
Photo 5: View of composite soil samples collected from the center side wall berm.

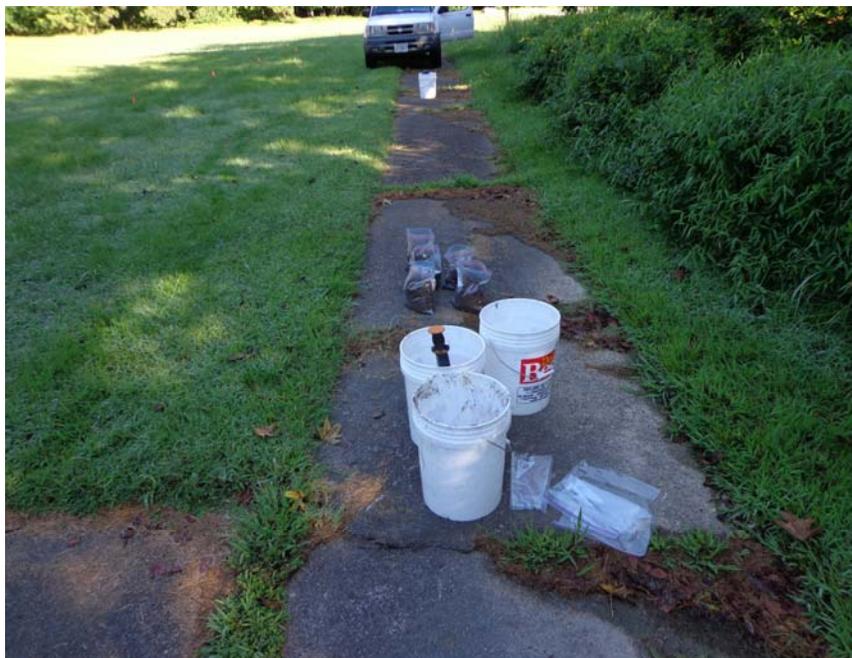
Photo 6: View of composite soil samples collected from the center side wall berm.
